Assessment of technical condition of Kherwar dam - feasibility study

***Publisher: Ministry of Foreign Affairs of the Czech Republic,
Provincial Reconstruction Team, Logar, Afghanistan***

Logar province, Afghanistan, April 2010

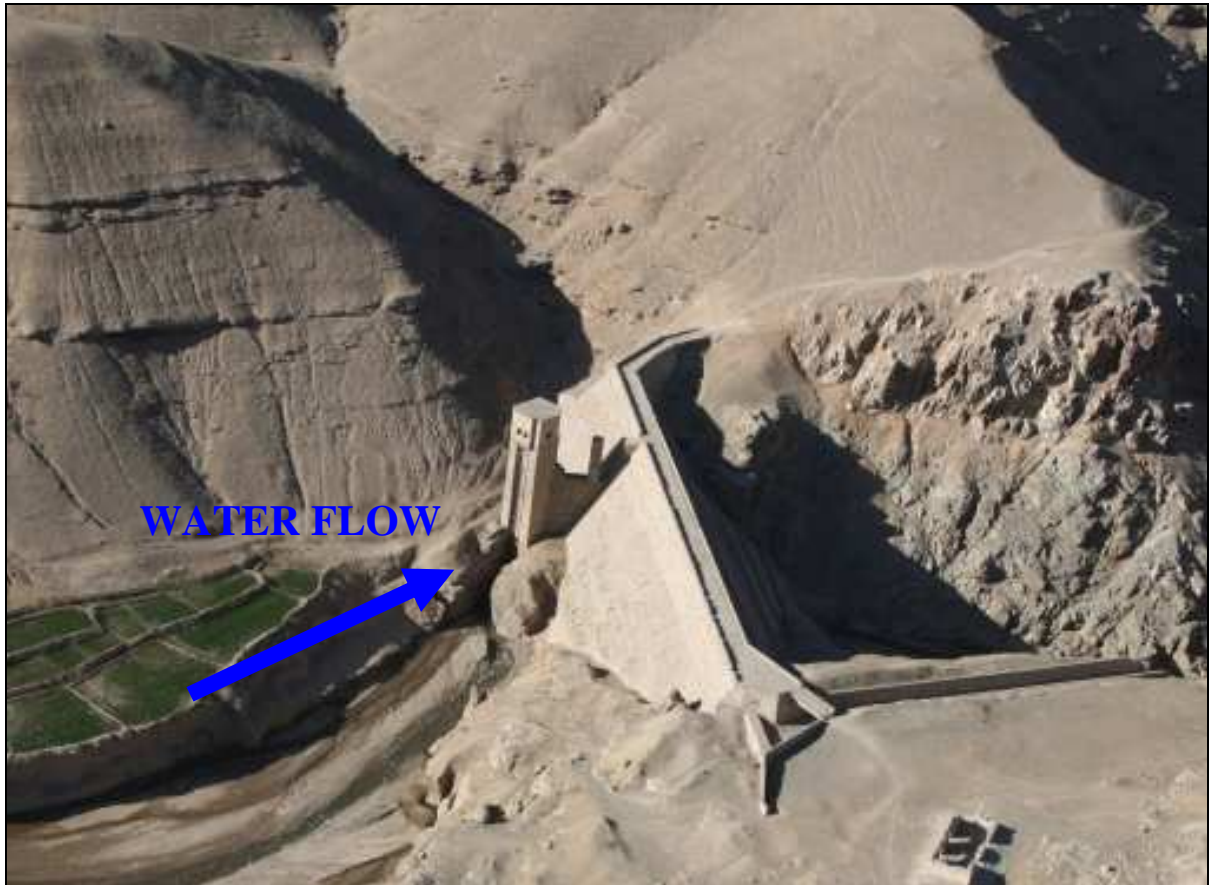
Pic.8 – Aerial photograph of water facing of the dam with control tower.

We performed air recco (Nov 4, 2009) that revealed incompleteness of all operational objects and their sequences. Dam body is probably made of stone packing with stone facing filled-out with cementation mortar. We have no information about quality of inner part of the dam. The dam was never full filled with water so the dam body pip shall be in a good condition because water never had a chance to destroy it. Facing of the dam is evidently damaged by erosion (some of the stones fell out of the wall and cementation mortar is infringed).

There is a control tower at the culvert. This tower unfortunately doesn't have any access way. There is a bridge missing, that would connect the tower and the dam crest. Since the tower is not accessible, nobody can assess what kind of device is inside and whether it is operational. Supposedly it is a device to operate/handle the culvert (drain) stopper. So we don't know if the device is useable or if it is repairable or if it needs to be changed. Technical condition of the tower only seems to be good. Foundation of the tower is set to rock ledge of sandstone so it shall be stable.

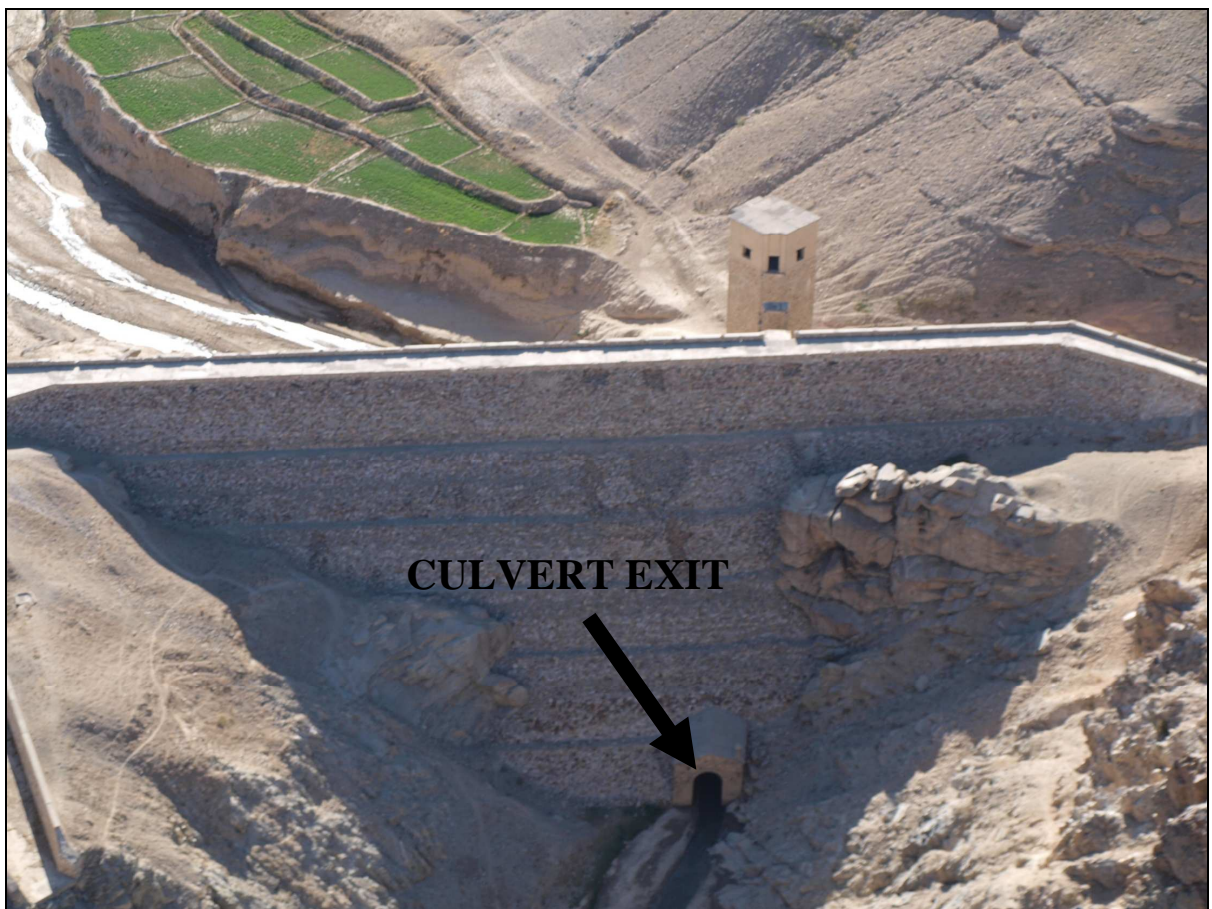
Pic.9 – Aerial photograph of air facing of the dam.

Bottom culvert (drain) is functional. It is evident through the observed water flow. The issue remains what is the technical condition inside the culvert (technical condition of the culvert from the point of view of permeability).

There is supposed to be an insulation layer between the water flowing through the culvert (drain) and the inner dam body. If the water leaks into dam body through the poorly insulated or damaged culvert, it has probably caused damages inside the dam body. However, these are only our assumptions, since we did not have opportunity to make closer survey of the dam. Provincial Ministry of Water and Energy claims that entrance to the culvert heel is damaged and requires reconstruction.

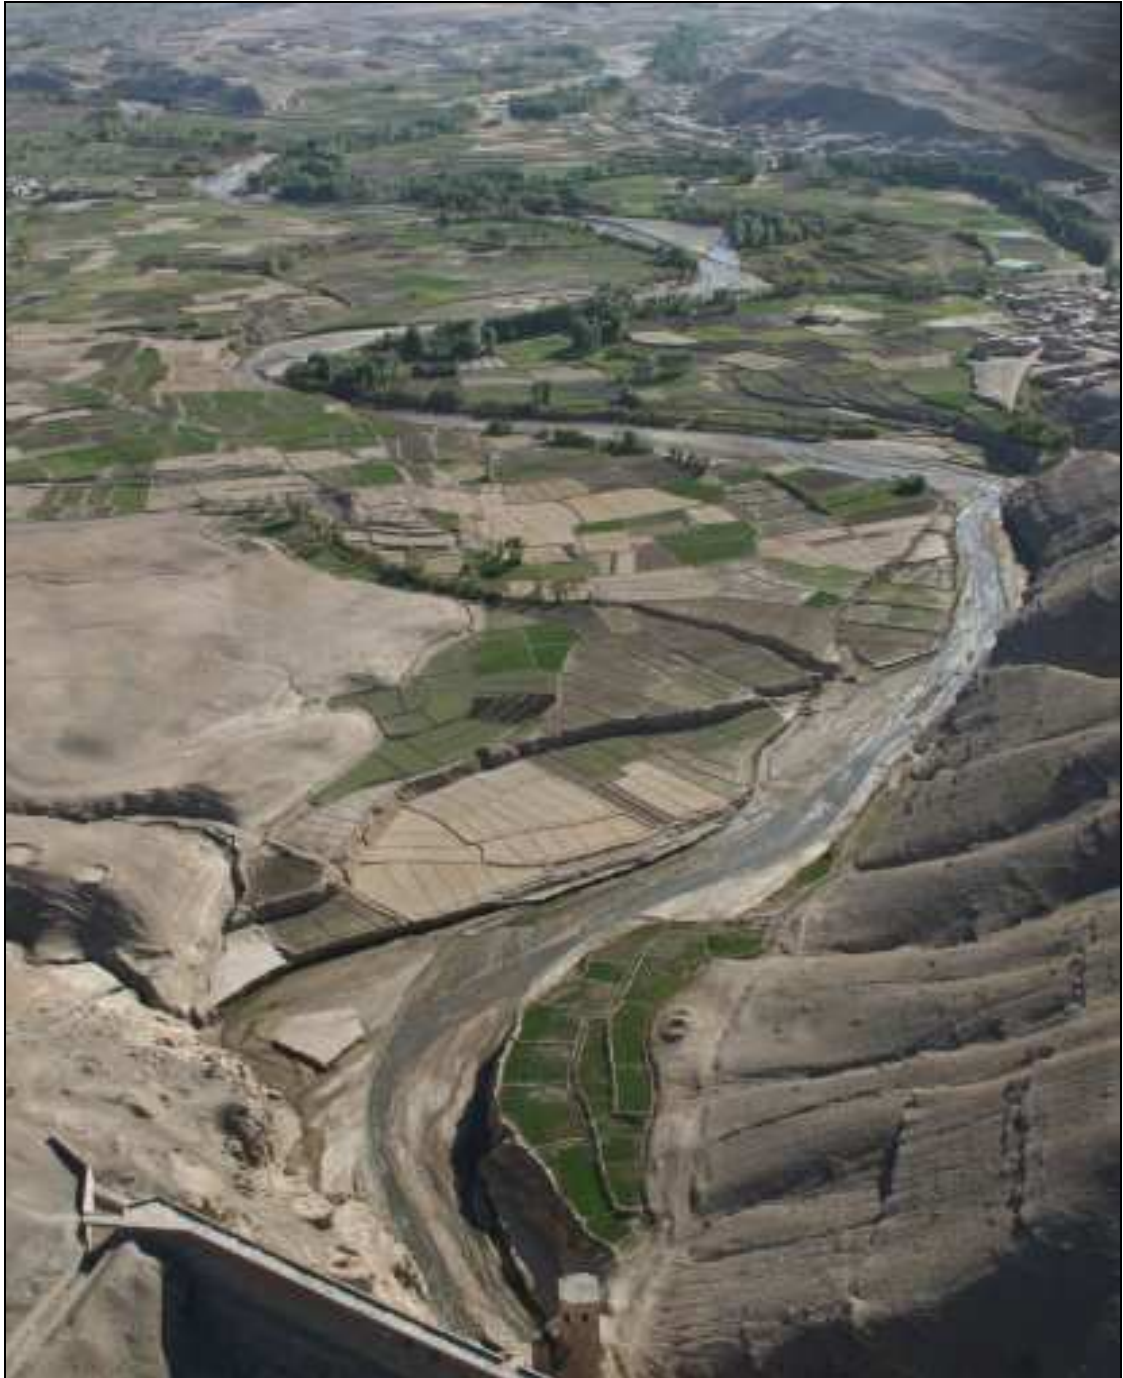
Pic.10 – Aerial photograph of potential submersion area.

The dam was built 70 years ago, and since then people already settled /inhabited the area of potential flowage and area of potential active capacity of the dam. It means that dam is now in unsuitable position. Agricultural land and also settled areas would be covered by water and justification between landowners would be really difficult. Map of affection area is drawn at picture no. 11. We have experiences from Surkhab dam. Surkhab was build about same time as Kherwar dam and the land issues are still pending.

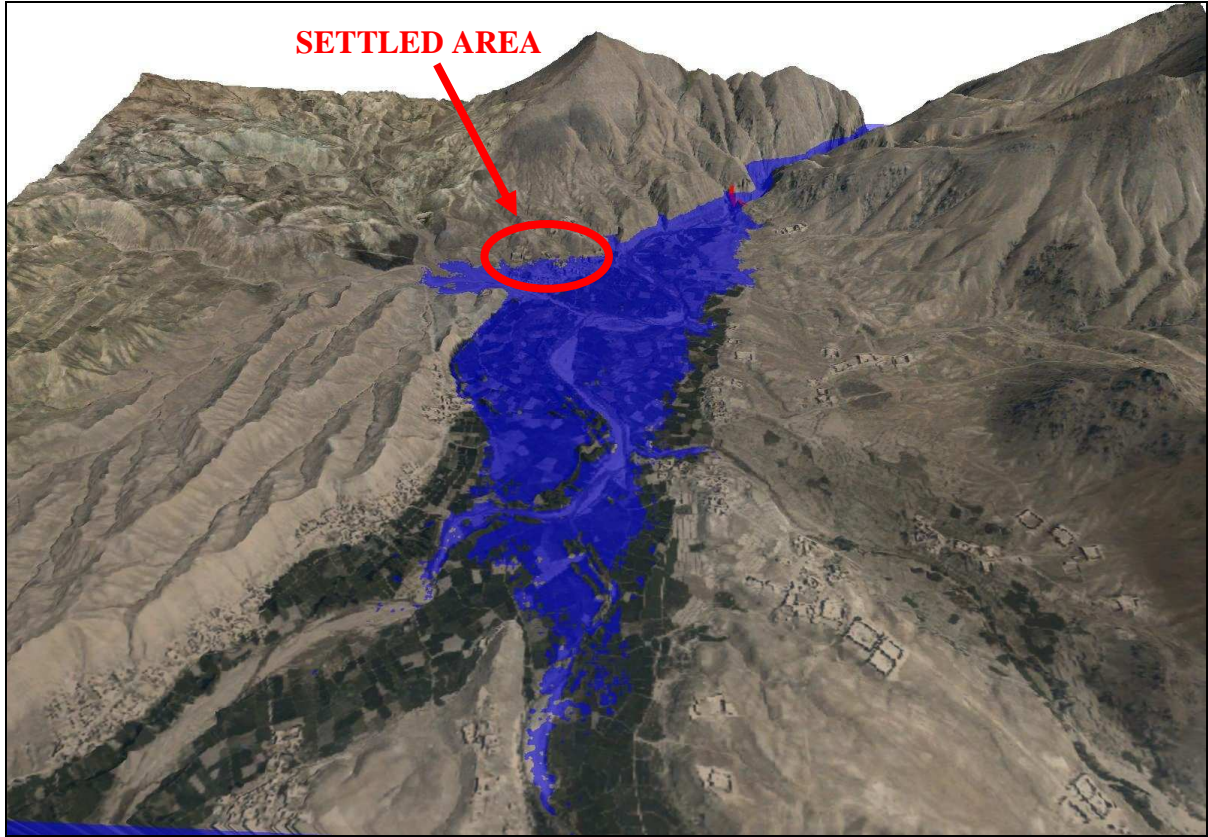
Pic. 11 – Active capacity of the dam (2430 m)

1. not enough water to fill the dam (low precipitation etc.)
2. the river stream would be so weak upon the exit from the dam that it would not reach the junction with Wardak river
3. all water would filter through the bottom of the dam (porous bottom) and the river would not continue at all
4. active capacity of the dam would submerge the to-be-irrigated fields (see pic.11)
